# UTAH STATE CAPITOL ARCHITECTURE: EXTERIOR SURVEY REPORT

ELEVATION LOCATION: SOUTH ELEVATION

Survey Date: 4/24/00

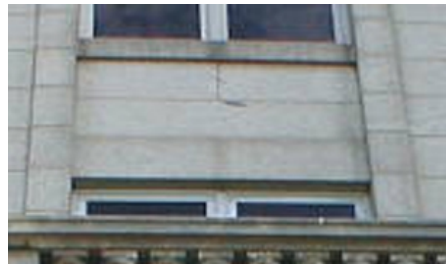
**Condition:** EX

Exfoliated or spalled surface

**Comments:** Efflorescence along upper edge under ledge of window trim.

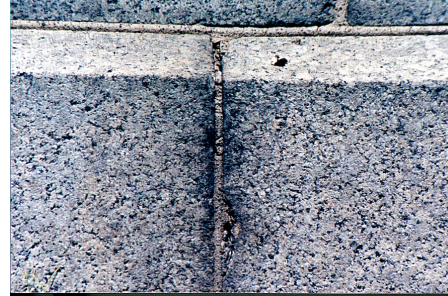
**Condition:** BR, J

Broken element, mortar joint damage

**Comments:** Vertical joint missing mortar (about 2'). On top piece 7-8" crack- about an inch from the joint- also vertical.

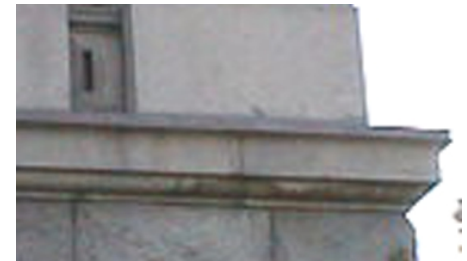
**Condition:** BR

Broken, severely cracked or chipped

**Comments:** Corner chipped 4" x 3".

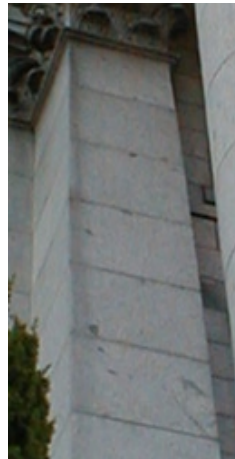
**Code:** EX-006**Description:** Pilaster shaft**Location:** upper section of shaft**Grid:** W 49-E**Condition:** PAT

Poor quality, non-matching patch

**Comments:** Bad patching.

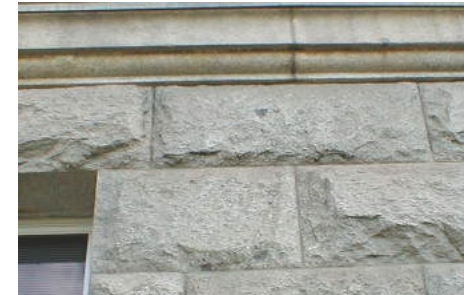
**Condition:** O

Other (describe)

**Comments:** Hole-#1/4" diameter

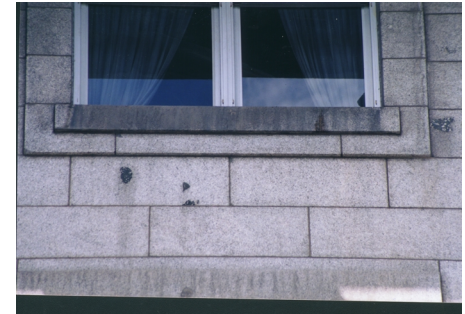
**Condition:** PAT

Poor quality, non-matching patch

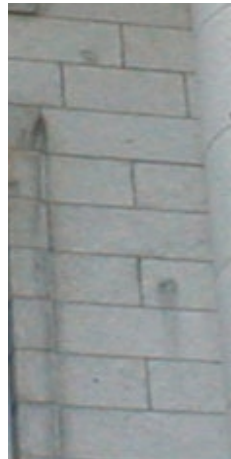
**Condition:** PAT

Poor quality, non-matching patch

**Comments:** Bad patches.

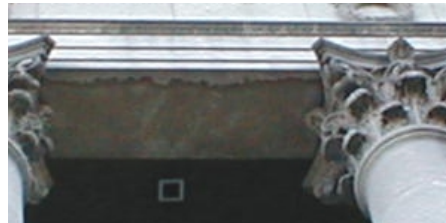
**Code: EX-009****Description: Entablature lower belt****Location:** under entablature lower belt of East wind.**Grid:** F typical**Condition:** ST

Significant Staining; may indicate rusted connector

**Comments:** Water stain under lower belt all along the East wind.

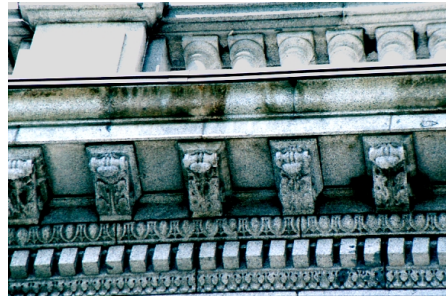
**Condition:** ST

Significant Staining; may indicate rusted connector

**Comments:** Stain mostly along the cornice.

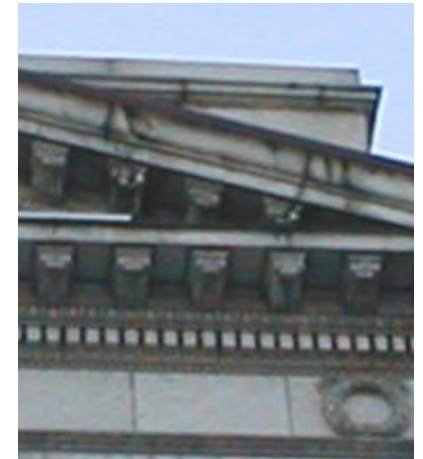
**Condition:** PAT

Poor quality, non-matching patch

**Comments:** Bad patching.

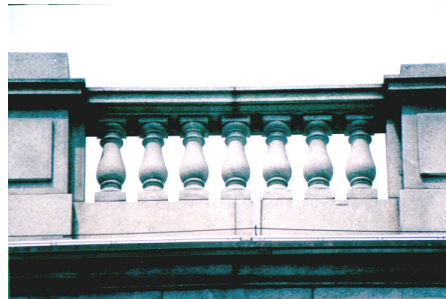
Significant Staining; may indicate rusted connector

**Comments:** Dark stains under the rail between the balusters- intermittently along whole of west wing.

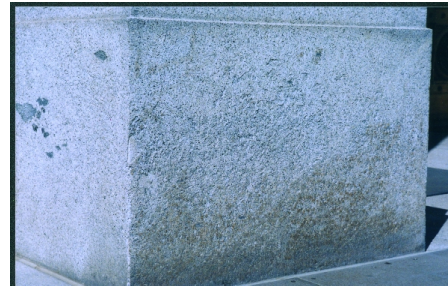
**Condition:** EX

Exfoliated or spalled surface

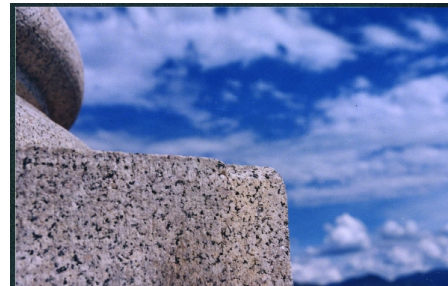
**Condition:** BR

Broken, severely cracked or chipped

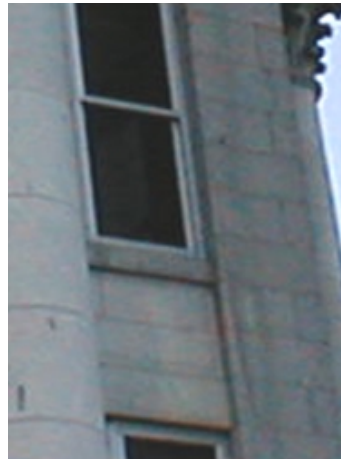
Poor quality, non-matching patch

**Comments:** Bad patching.

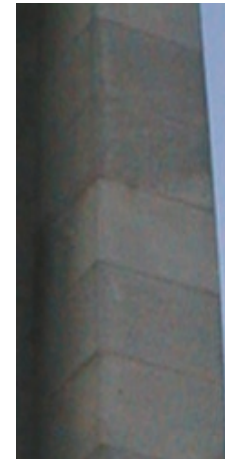
**Code:** EX-089**Description:** Stair wall**Location:** South-west sides of square column**Grid:** E 190.5-E & D**Condition:** BRBroken, severely cracked or  
chipped**Comments:**

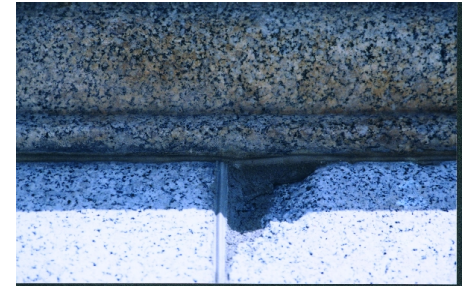
Broken, severely cracked or  
chipped

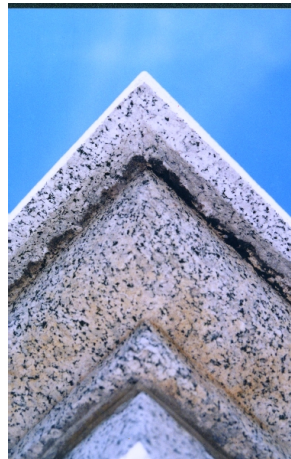
Broken, severely cracked or  
chipped

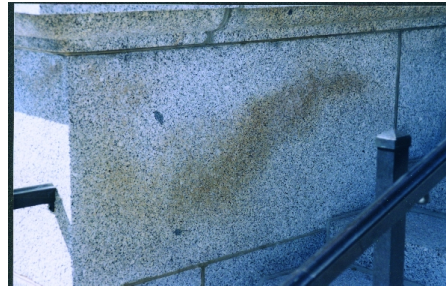
**Condition:** EX

Exfoliated or spalled surface

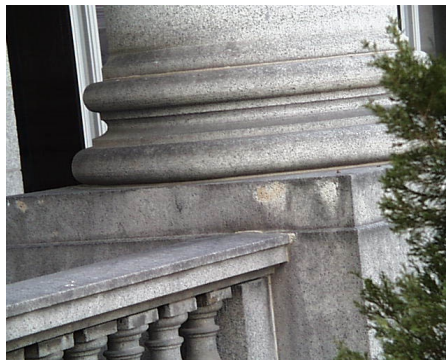
Poor quality, non-matching patch

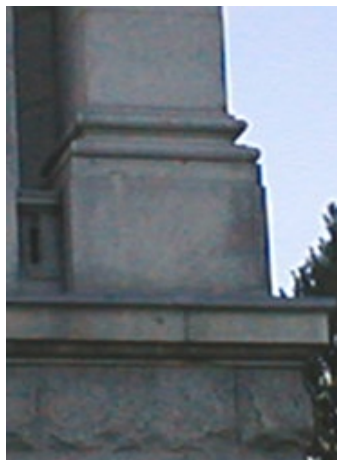
Poor quality, non-matching patch

**Comments:** Bad patch

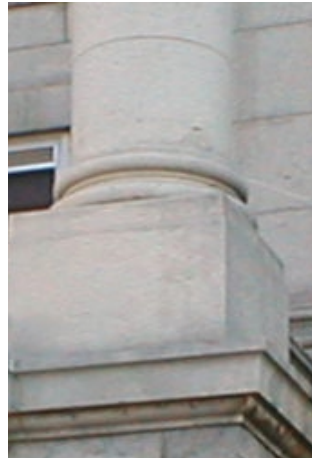
Other (describe)

**Comments:** small holes

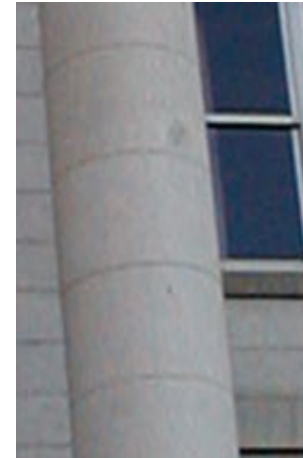
Poor quality, non-matching patch
